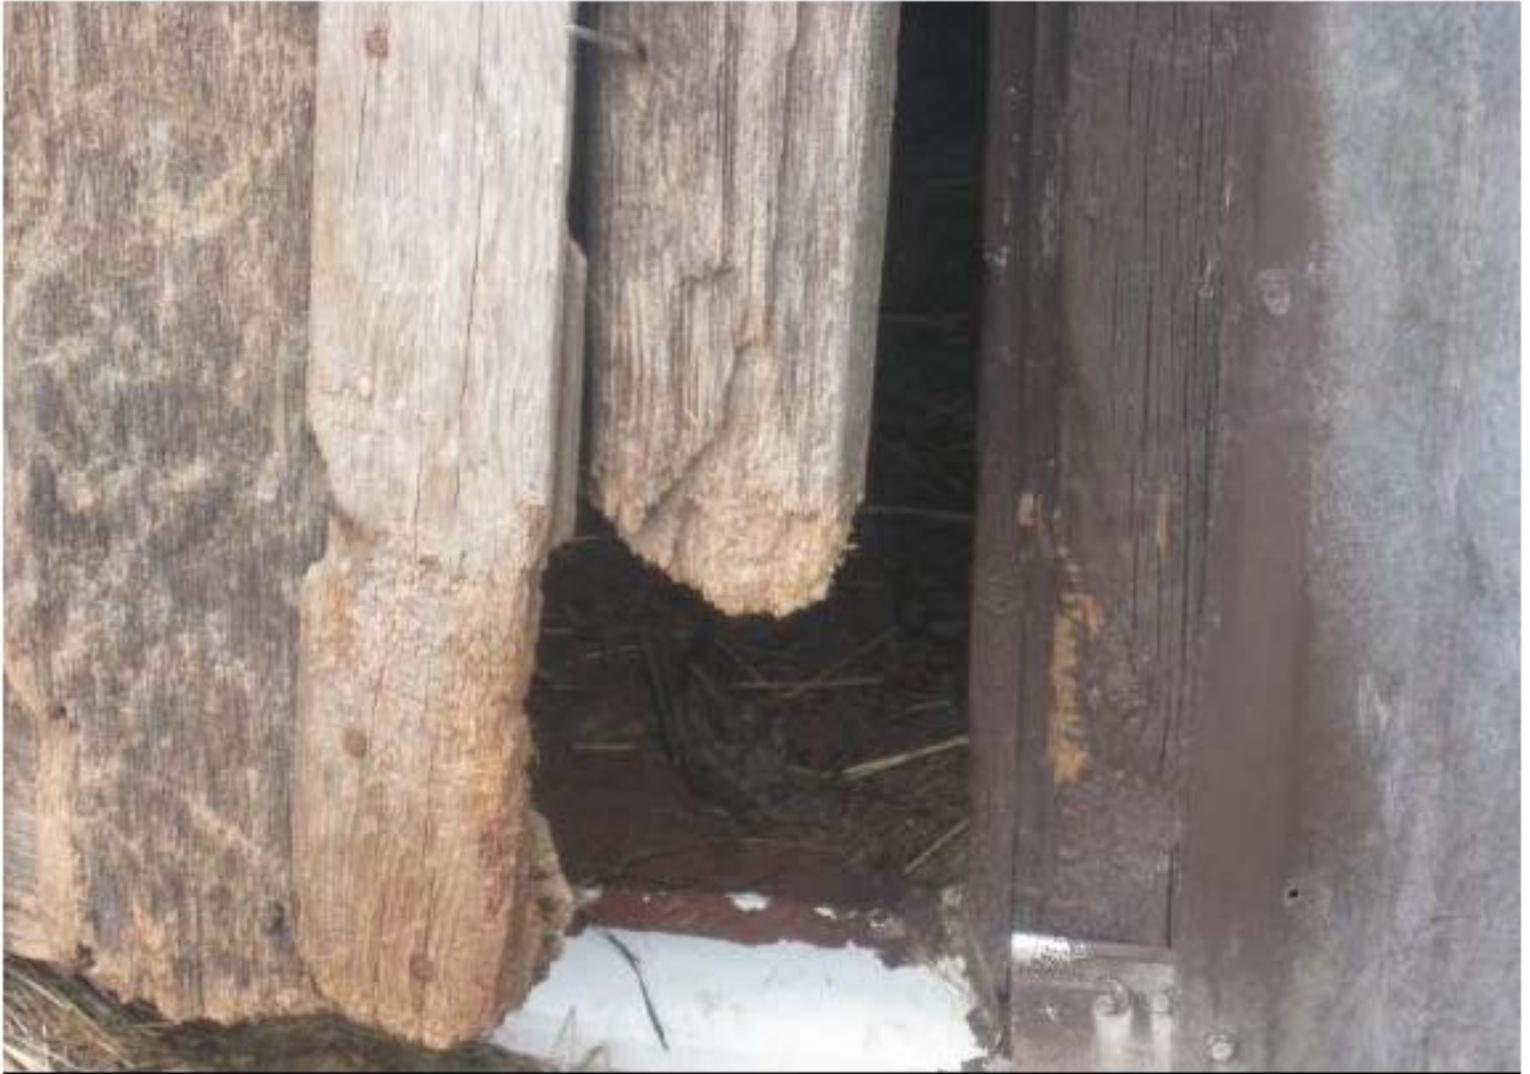
Photographer:	Dr. Watkins	Legal Name:	Registration:	42-A-1256
Photo Taken:	Thu, Feb 11, '10	BETTY PORTER		
Inspection:	53101231270064			
Description:	Chewed wood

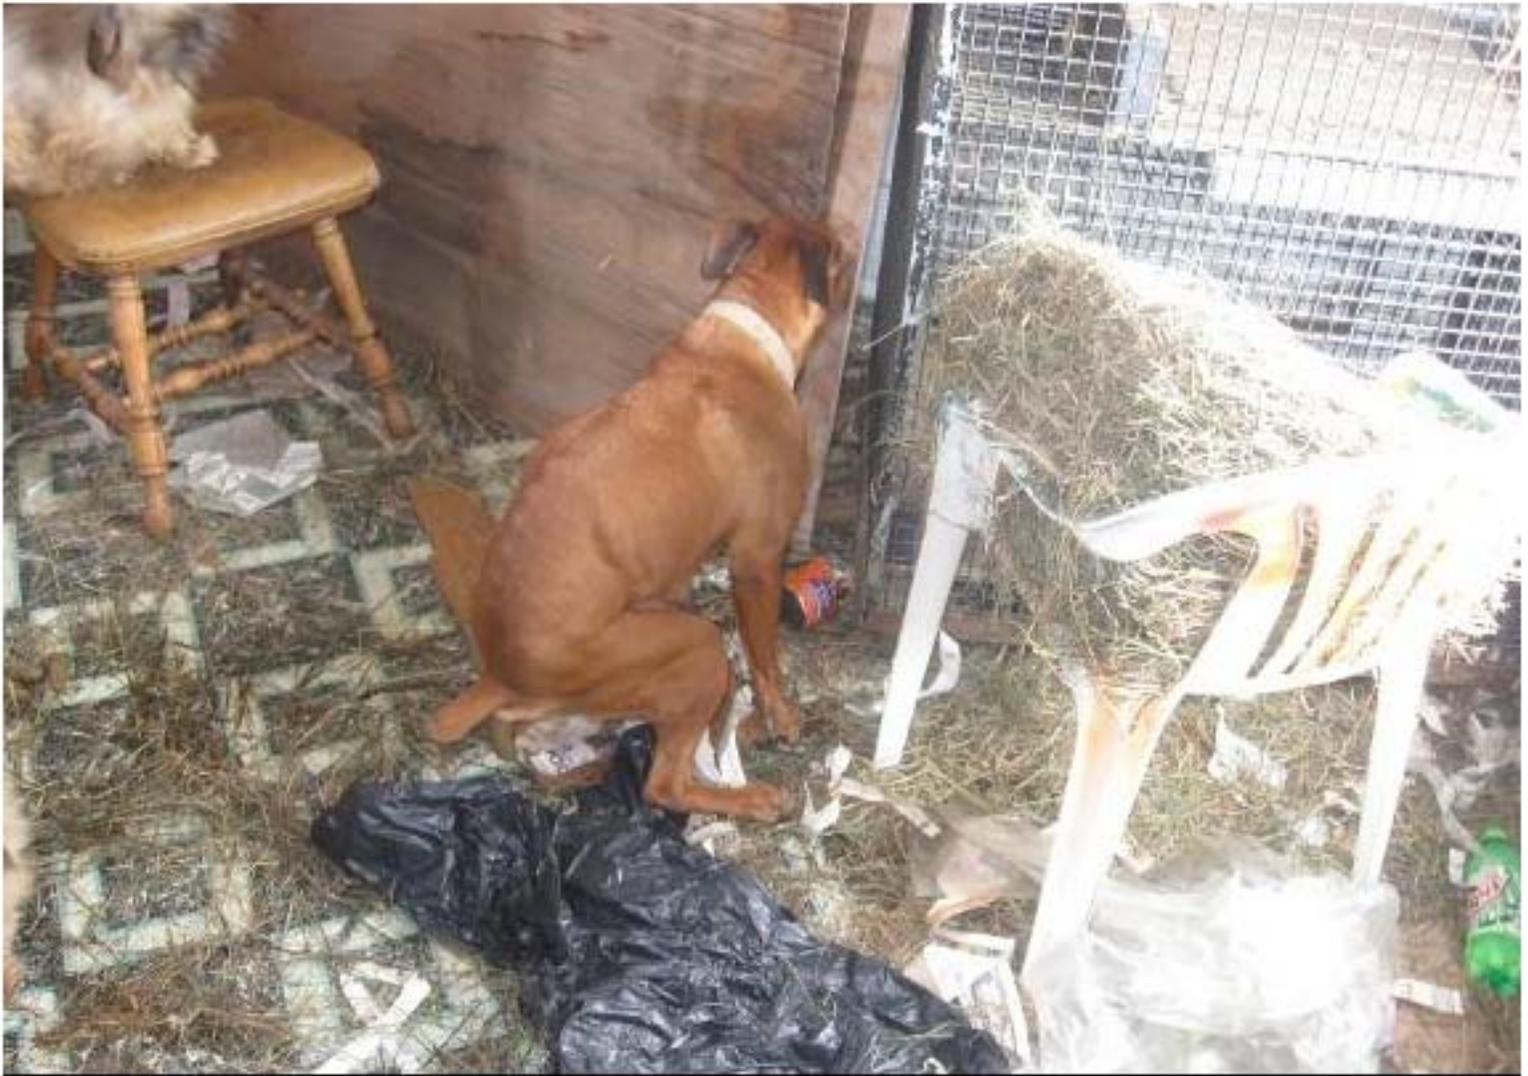
Photographer:	Dr. Watkins	Legal Name:	Registration:	42-A-1256
Photo Taken:	Thu, Feb 11, '10	BETTY PORTER		
Inspection:	53101231270064			
Description:	Female Boxer in whelping area, relieving itself in open area of trailer. Other dog running loose as well. Area is strewn with feces, debris and clutter.

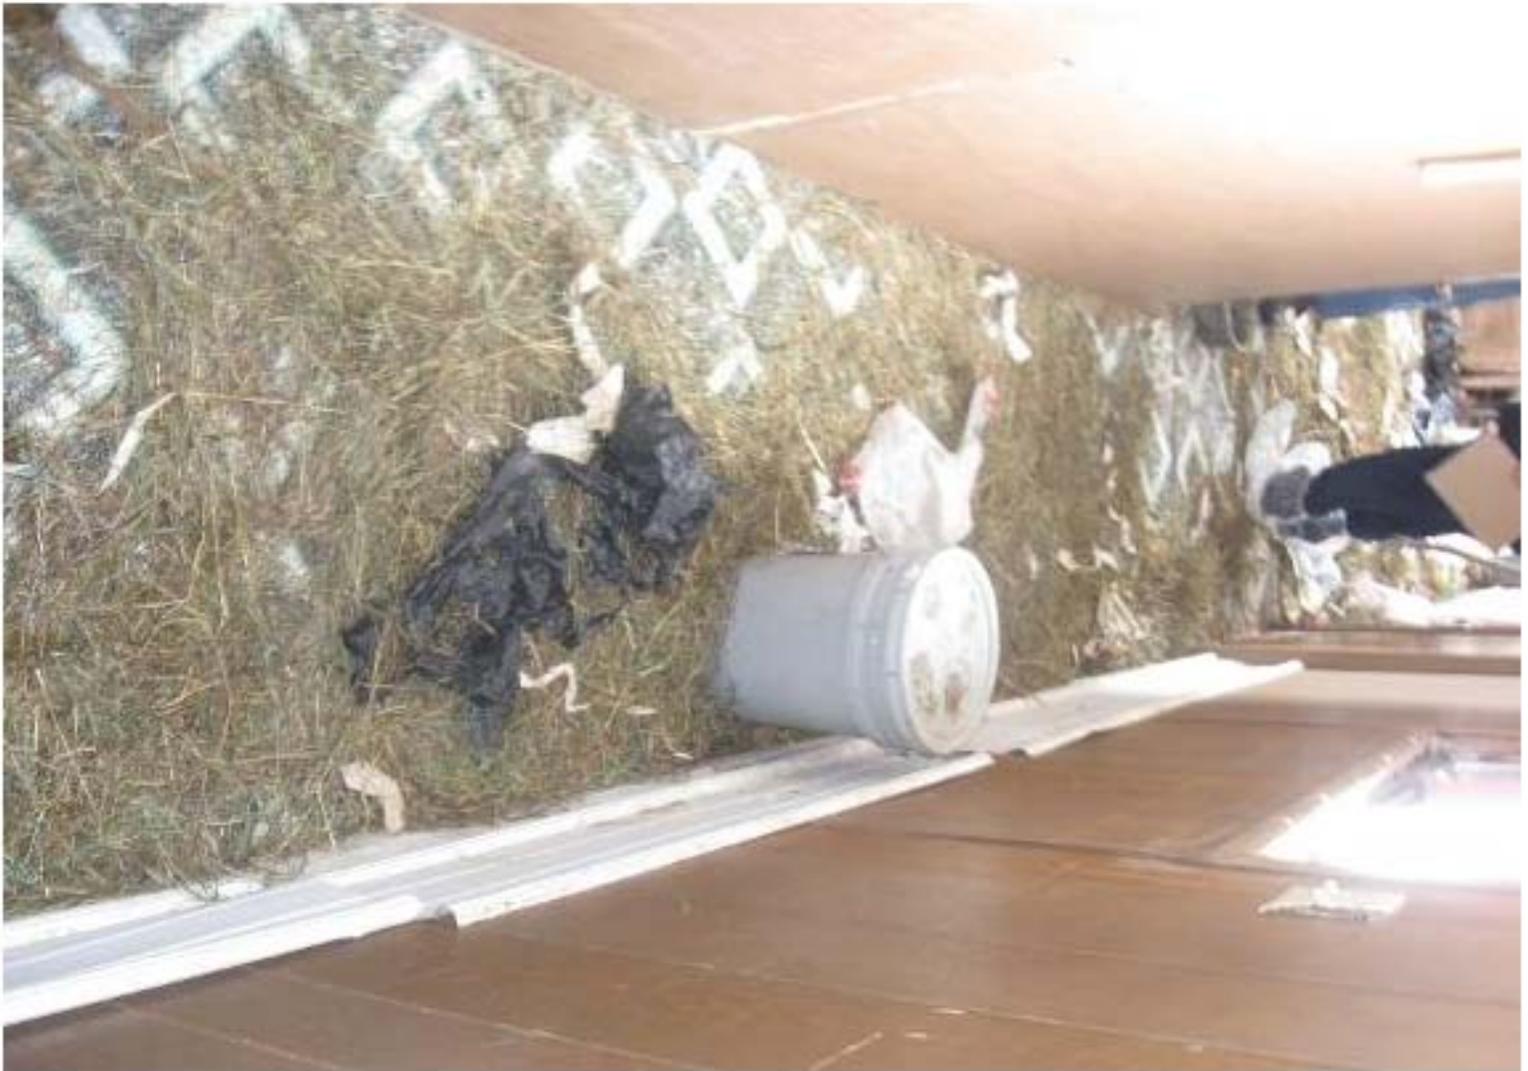
Photographer:	Dr. Watkins	Legal Name:	Registration:	42-A-1256
Photo Taken:	Thu, Feb 11, '10	BETTY PORTER		
Inspection:	53101231270064			
Description:	Clutter, debris in whelping area

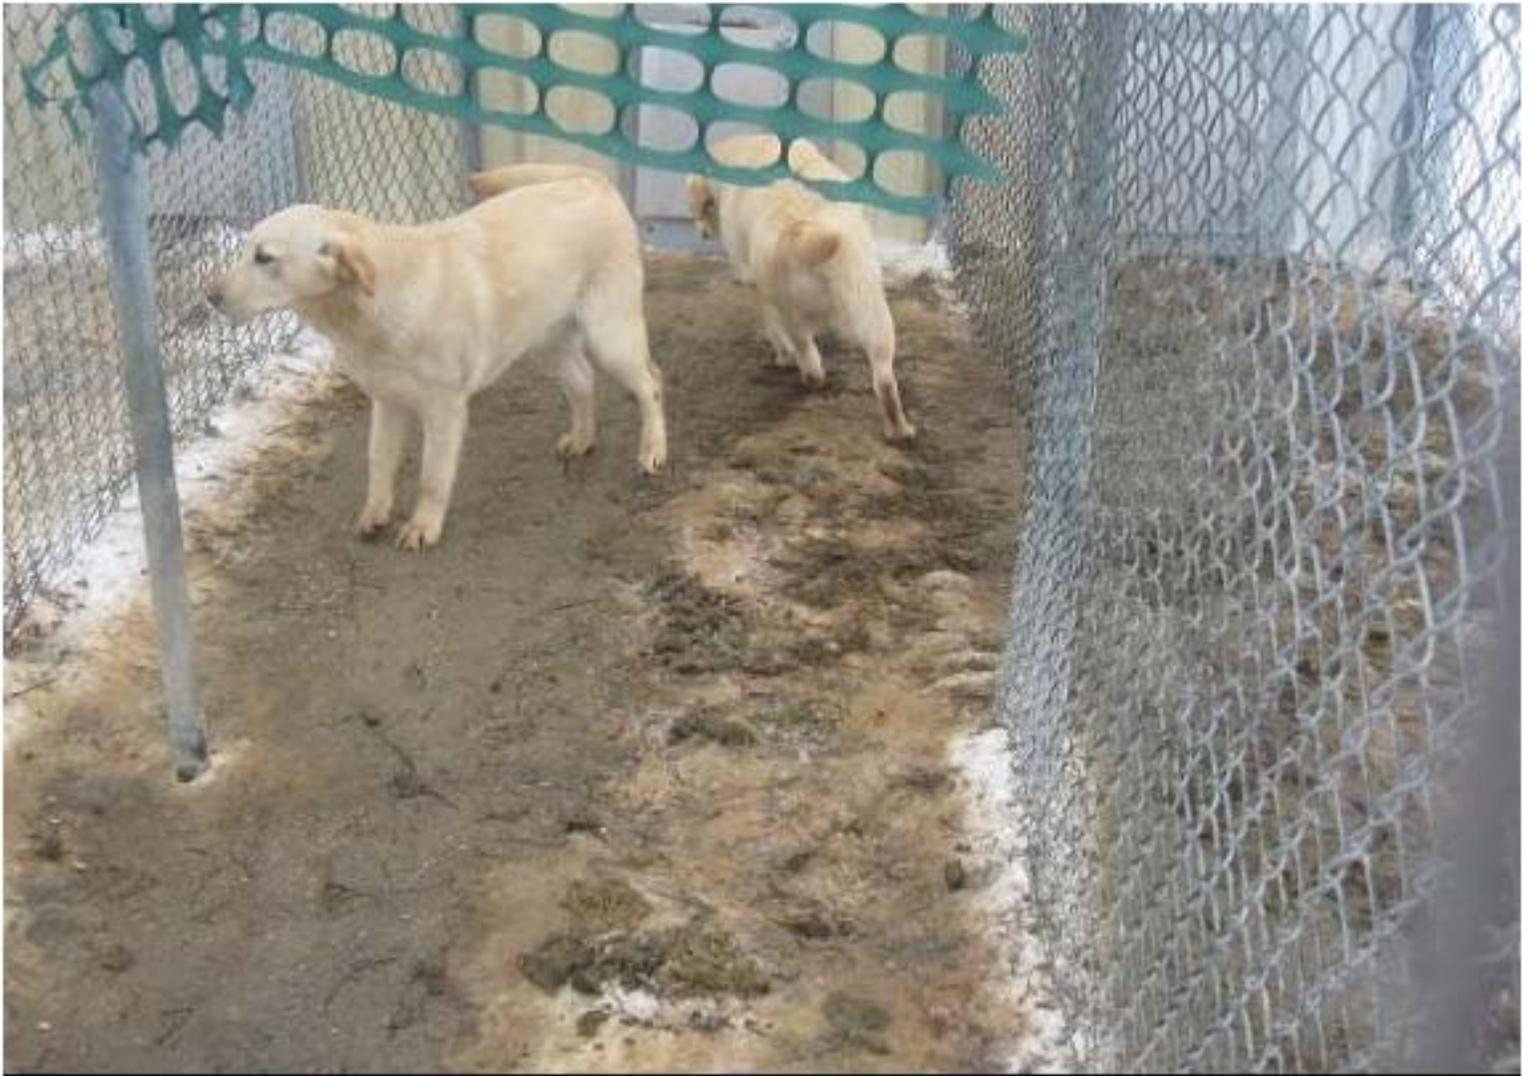
Photographer:	Dr. Watkins	Legal Name:	Registration:	42-A-1256
Photo Taken:	Thu, Feb 11, '10	BETTY PORTER		
Inspection:	53101231270064			
Description:	Fencing not connected at bottom

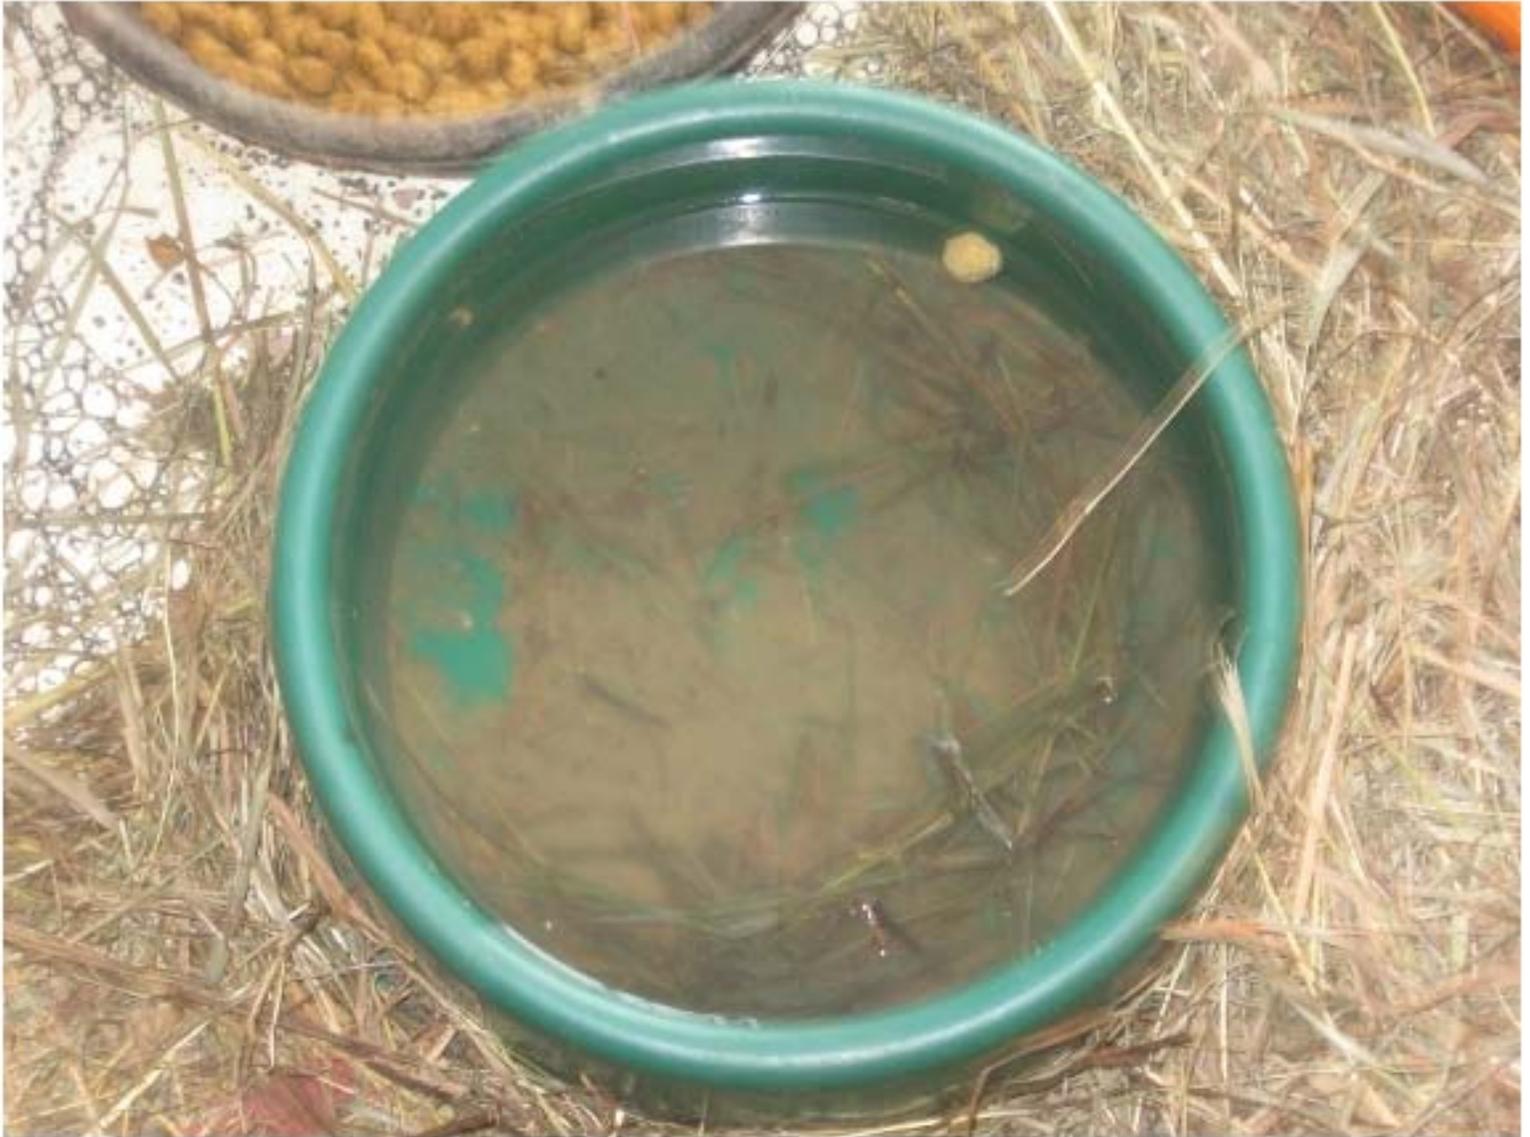
Photographer:	Dr. Watkins	Legal Name:	Registration:	42-A-1256
Photo Taken:	Thu, Feb 11, '10	BETTY PORTER		
Inspection:	53101231270064			
Description:	Sludge buildup in water dish in whelping area

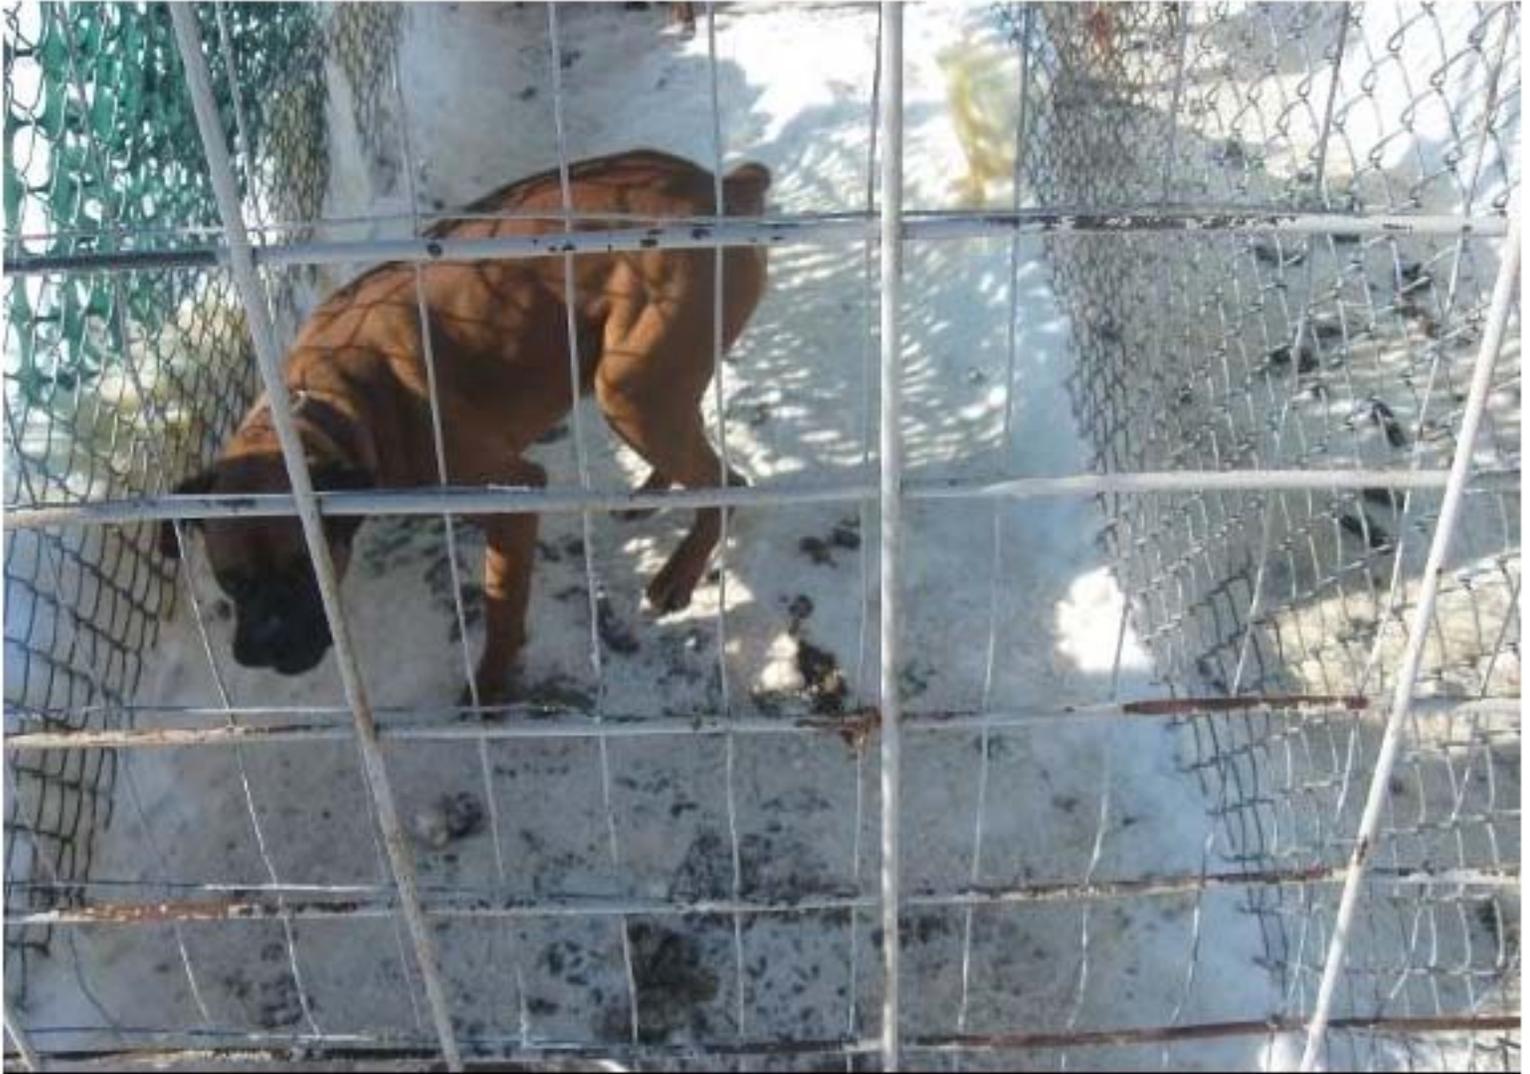
Photographer:	Brenda Pietrosante	Legal Name:	Registration:	42-A-1256
Photo Taken:	Tue, Jan 12, '10 1:20pm central	BETTY PORTER		
Inspection:	14100803100482			
Description:	Excreta and snow build up

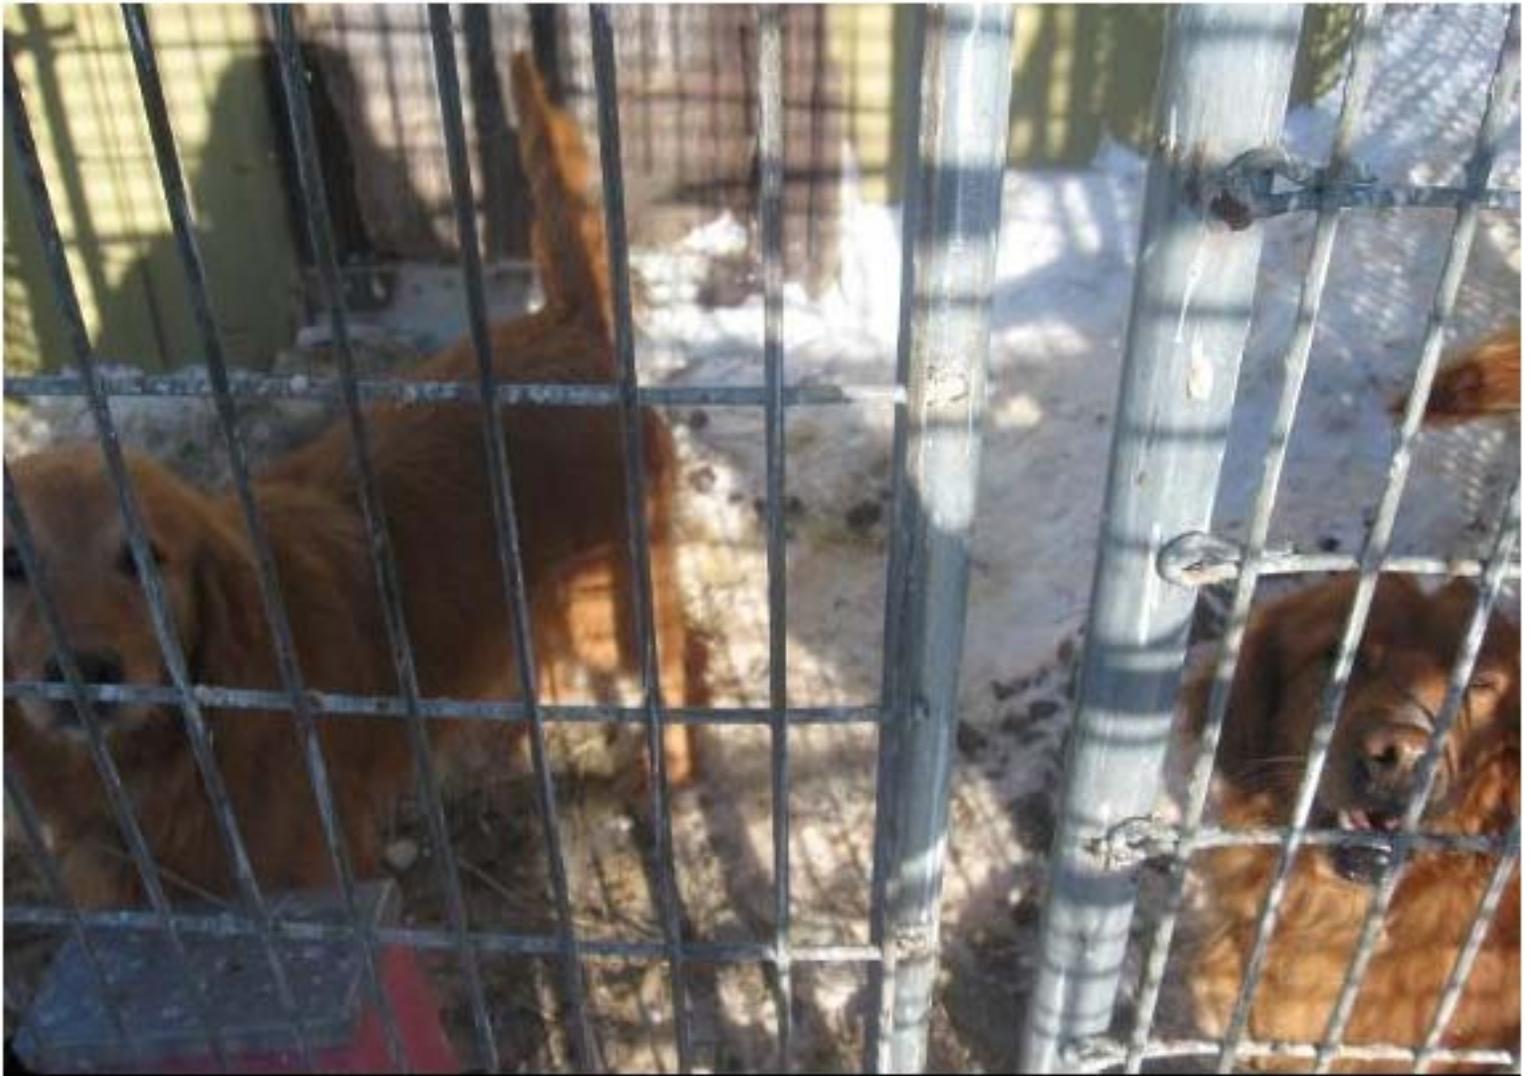
Photographer:	Brenda Pietrosante	Legal Name:	Registration:	42-A-1256
Photo Taken:	Tue, Jan 12, '10 1:00pm central	BETTY PORTER		
Inspection:	14100803100482			
Description:	Build up of excreta and snow

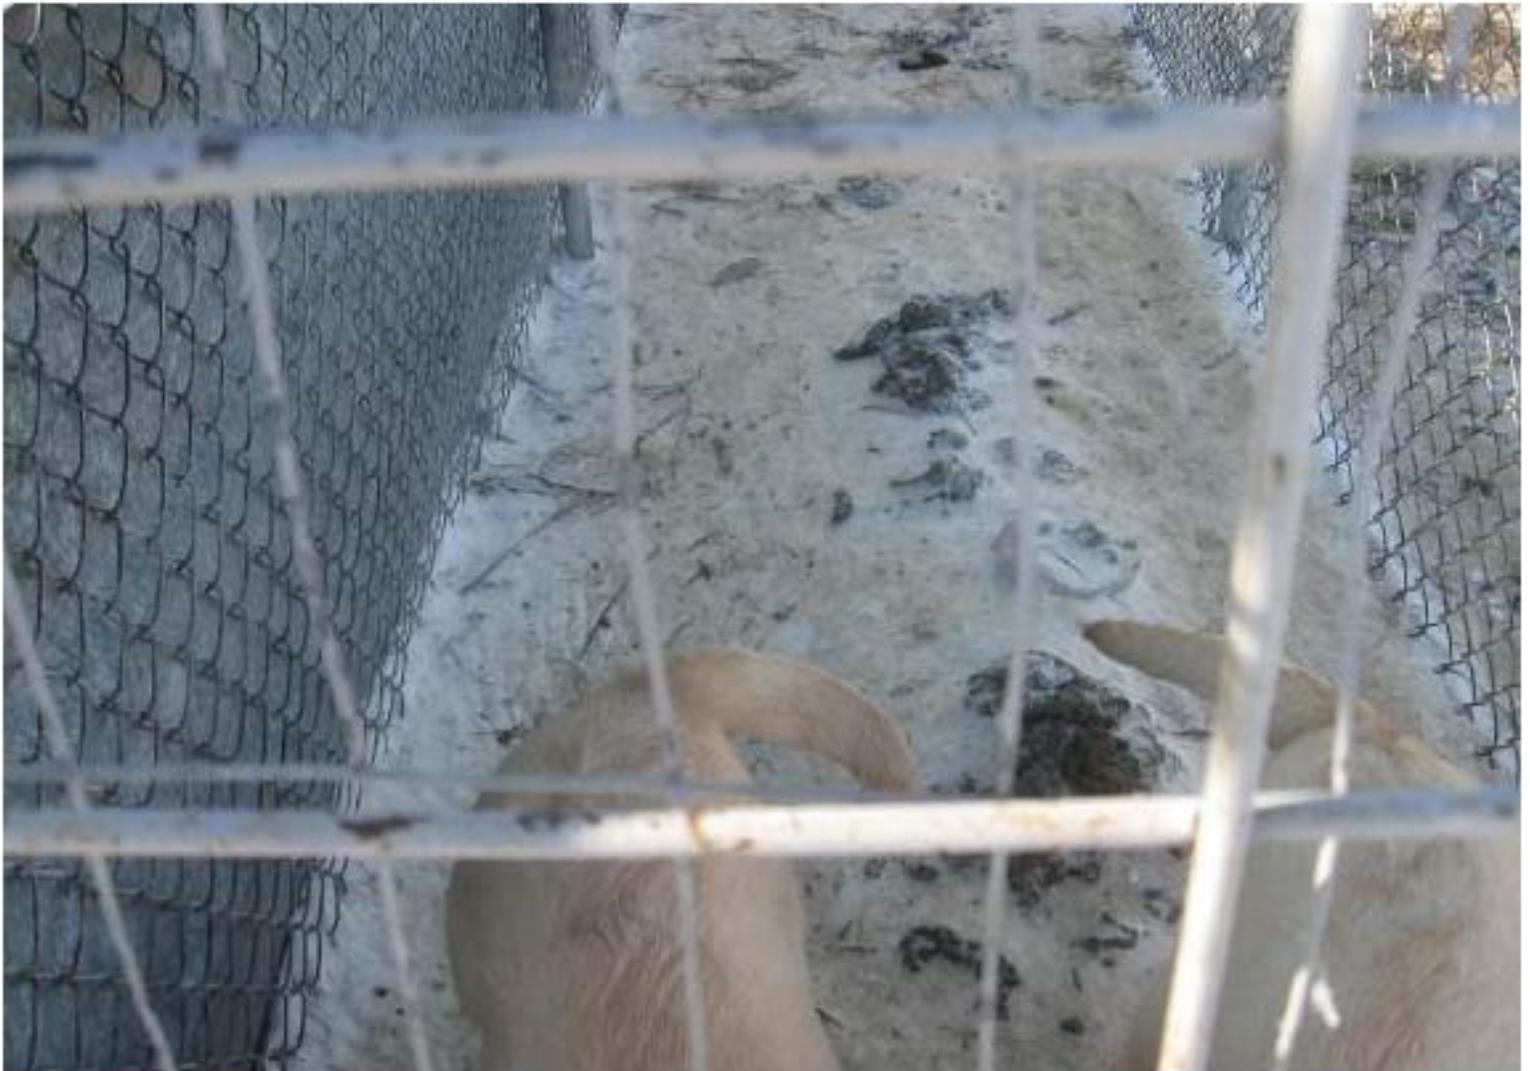
Photographer:	Brenda Pietrosante	Legal Name:	Registration:	42-A-1256
Photo Taken:	Tue, Jan 12, '10 1:10 pm central	BETTY PORTER		
Inspection:	14100803100482			
Description:	Build up of excreta and snow

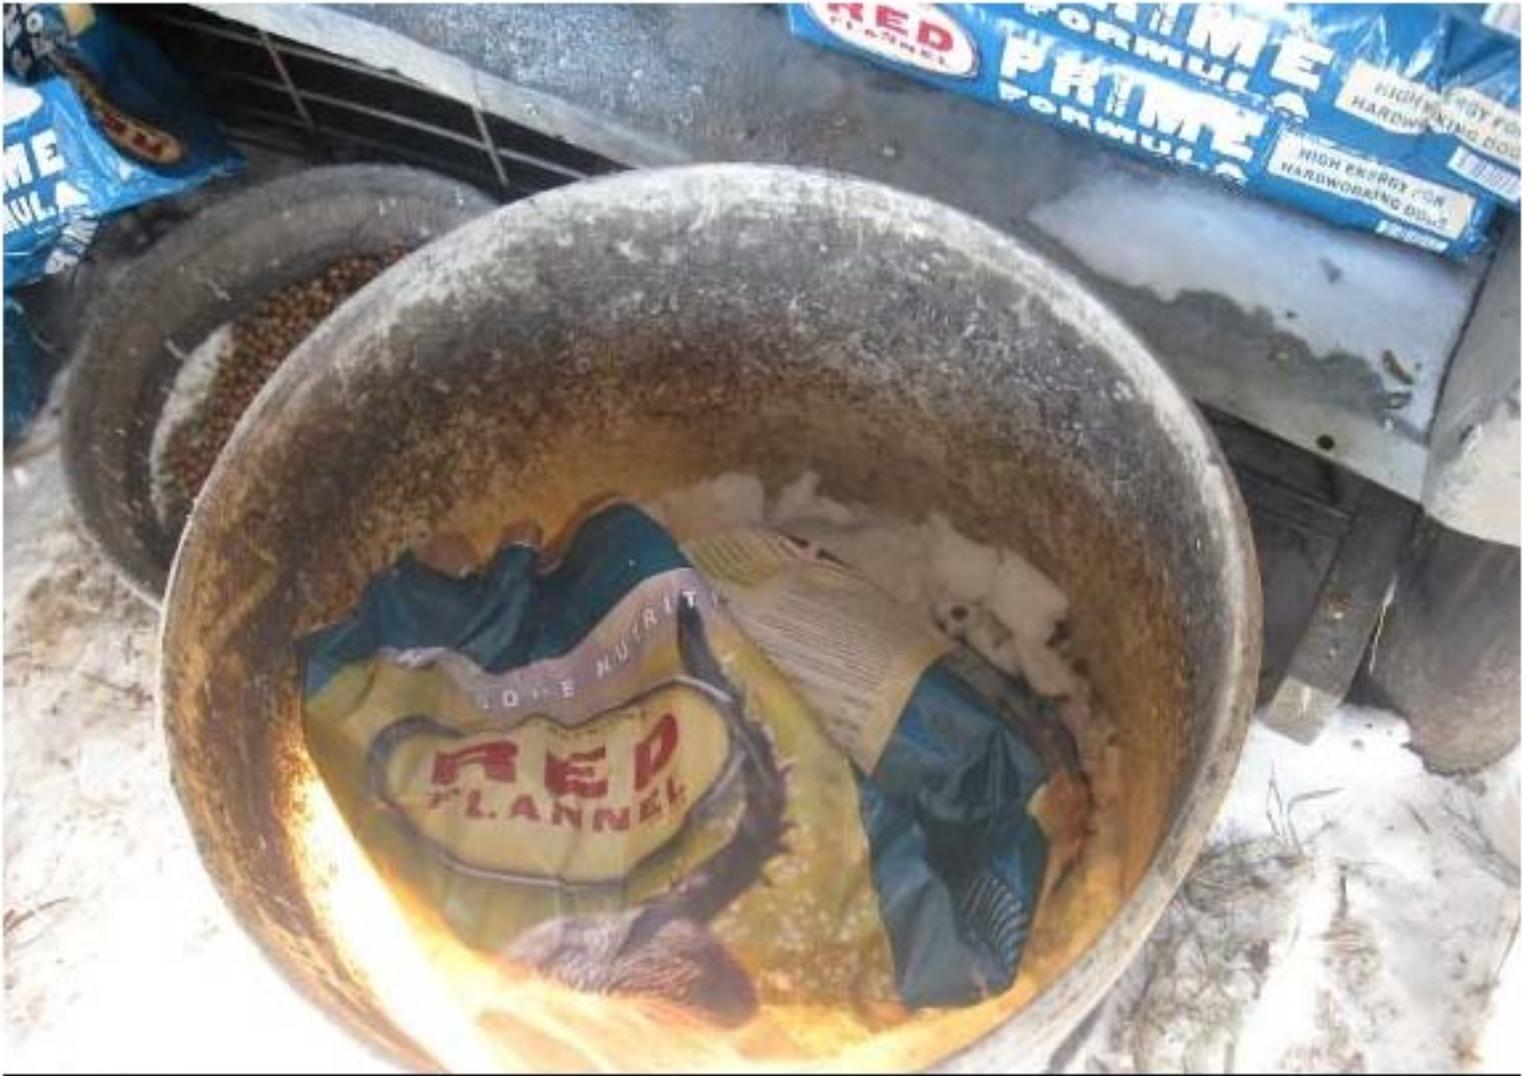
Photographer:	Brenda Pietrosante	Legal Name:	Registration:	42-A-1256
Photo Taken:	Tue, Jan 12, '10 1:30pm central	BETTY PORTER		
Inspection:	14100803100482			
Description:	Food supply kept in containers w/no lids, in snow, and strewn about debris

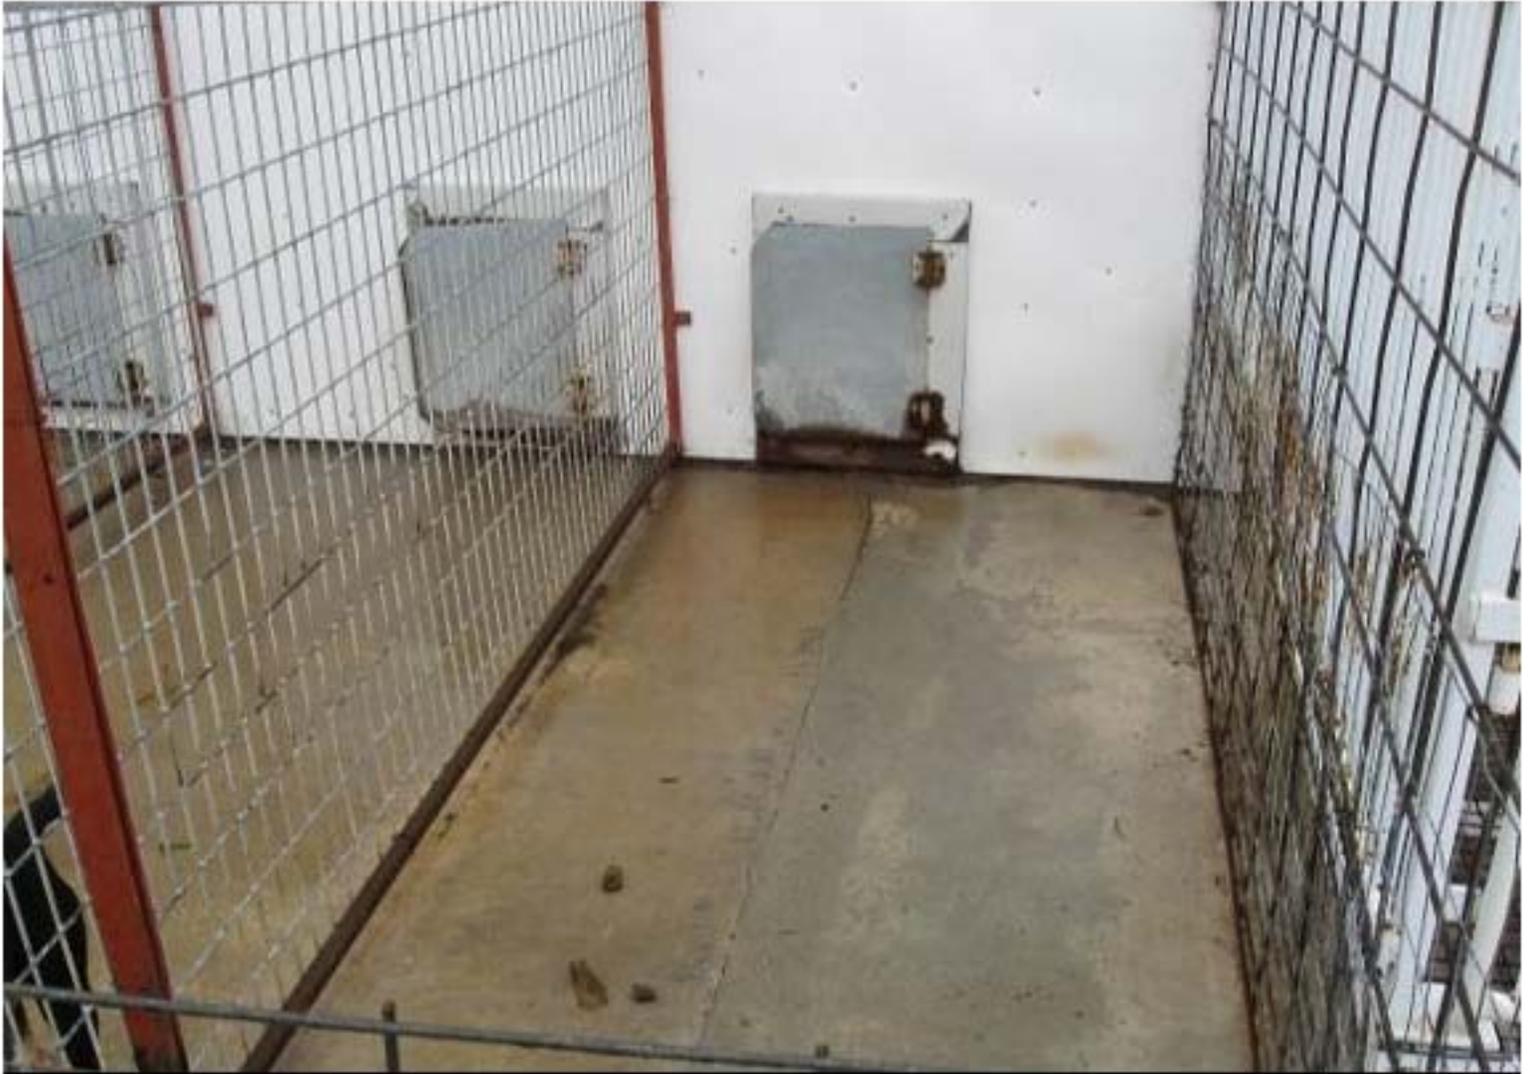
CFR: 3.1 (c) (1) (i)

Photographer:	Randall Wagner (ACI)	Legal Name:	Registration:	42-A-1253
Photo Taken:	Thu, Sep 23, '10	DAVE RUTER		
Inspection:	280100021210681			
Description:	The bottom of the metal door and bottom pipe framing are excessively rusty/flaking. The surface has rusted through in areas affecting the strength.

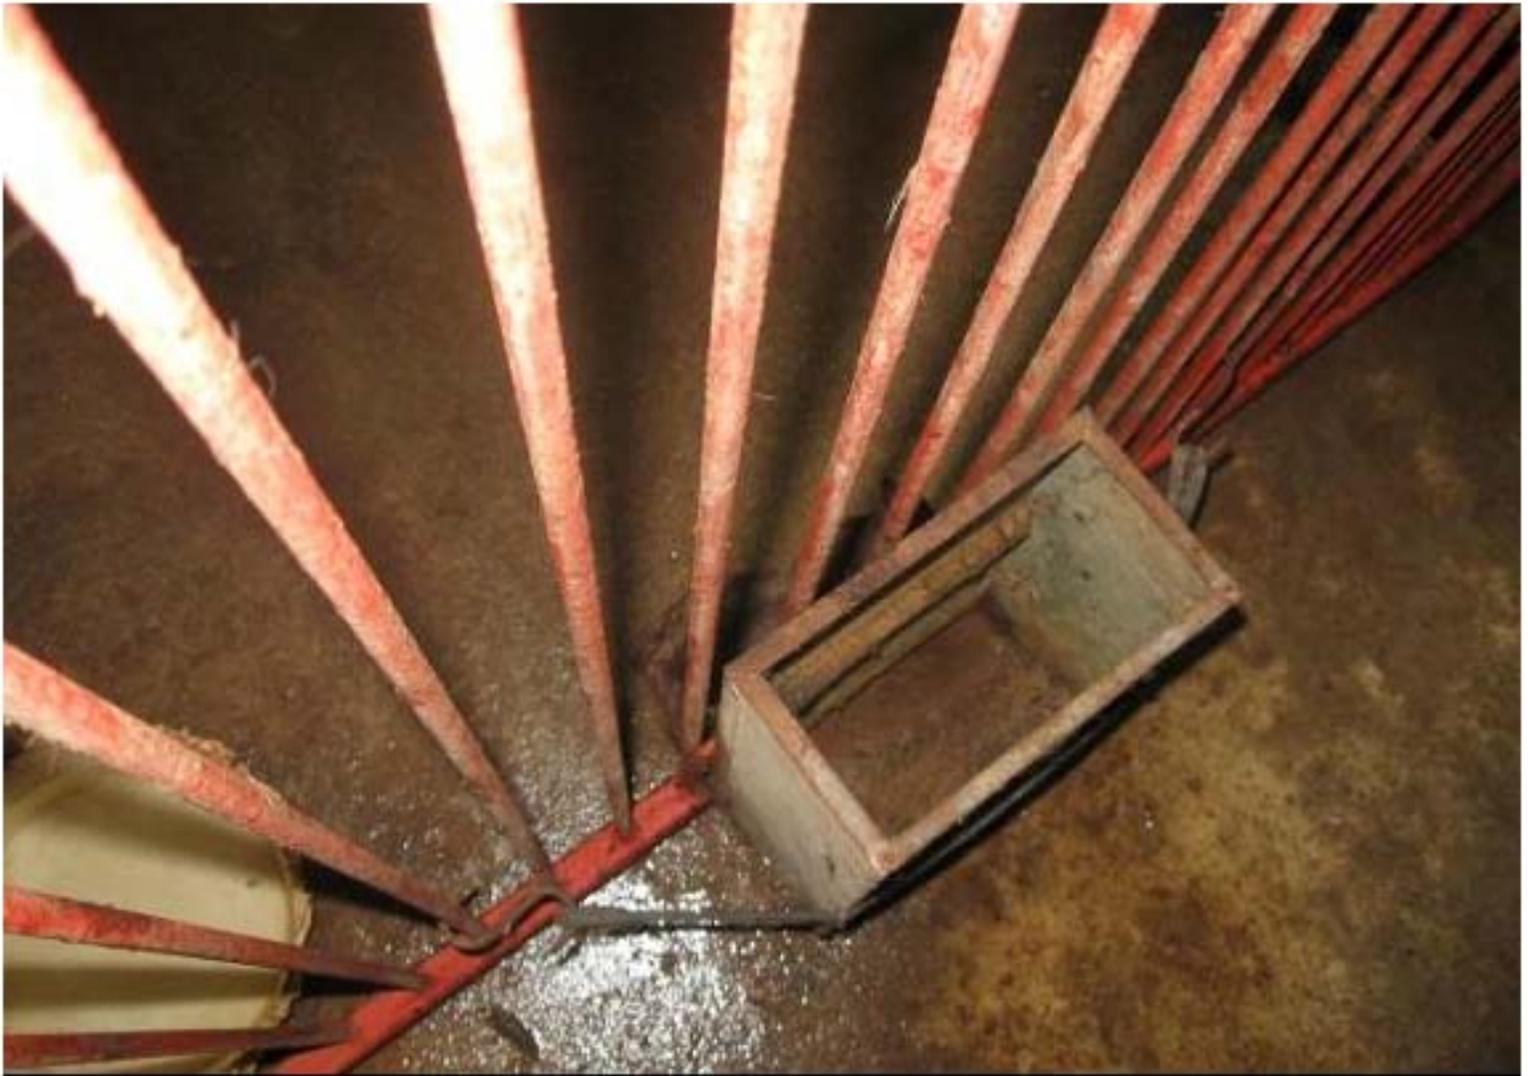
CFR: 3.1 (c) (1) (i)

Photographer:	Randall Wagner (ACI)	Legal Name:	Registration:	42-A-1253
Photo Taken:	Thu, Sep 23, '10	DAVE RUTER		
Inspection:	280100021210681			
Description:	The metal feeder is excessively rusty and the surface is flaking. The feeder is rusted apart in areas causing an edge.

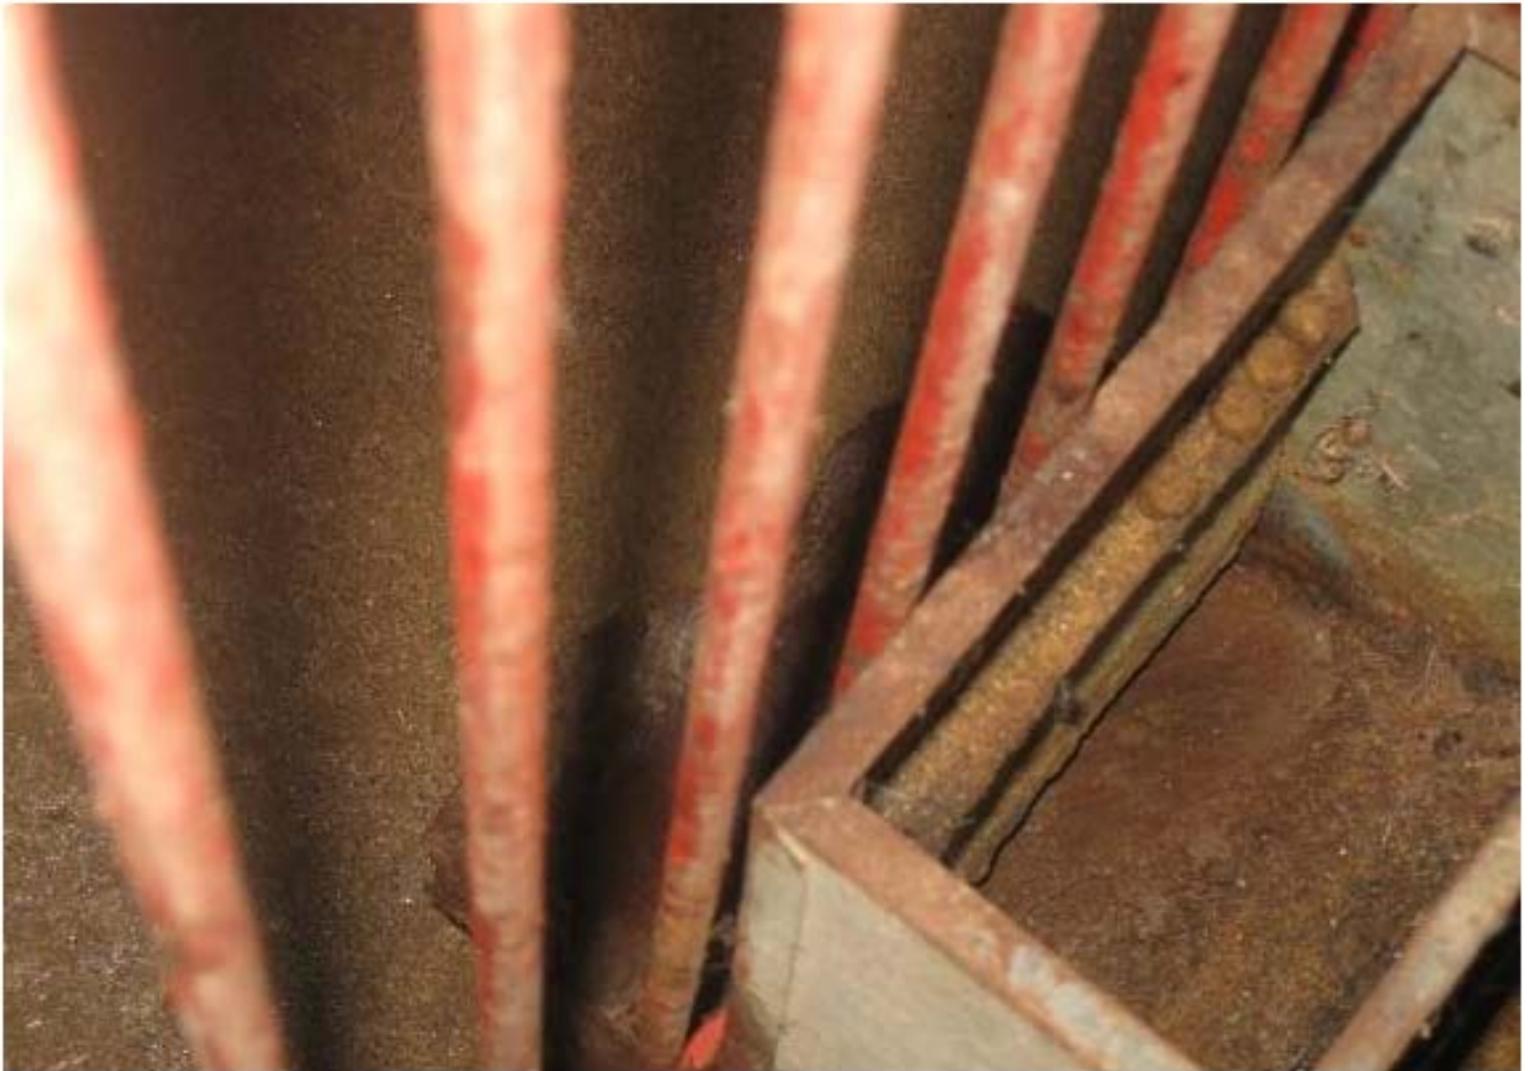
CFR: 3.1 (c) (1) (i)

Photographer:	Randall Wagner (ACI)	Legal Name:	Registration:	42-A-1253
Photo Taken:	Thu, Sep 23, '10	DAVE RUTER		
Inspection:	280100021210681			
Description:	Close in view of the bottom of the metal feeder, which surface is excessively rusty and flaking. An edge is caused by the rusting in the front.

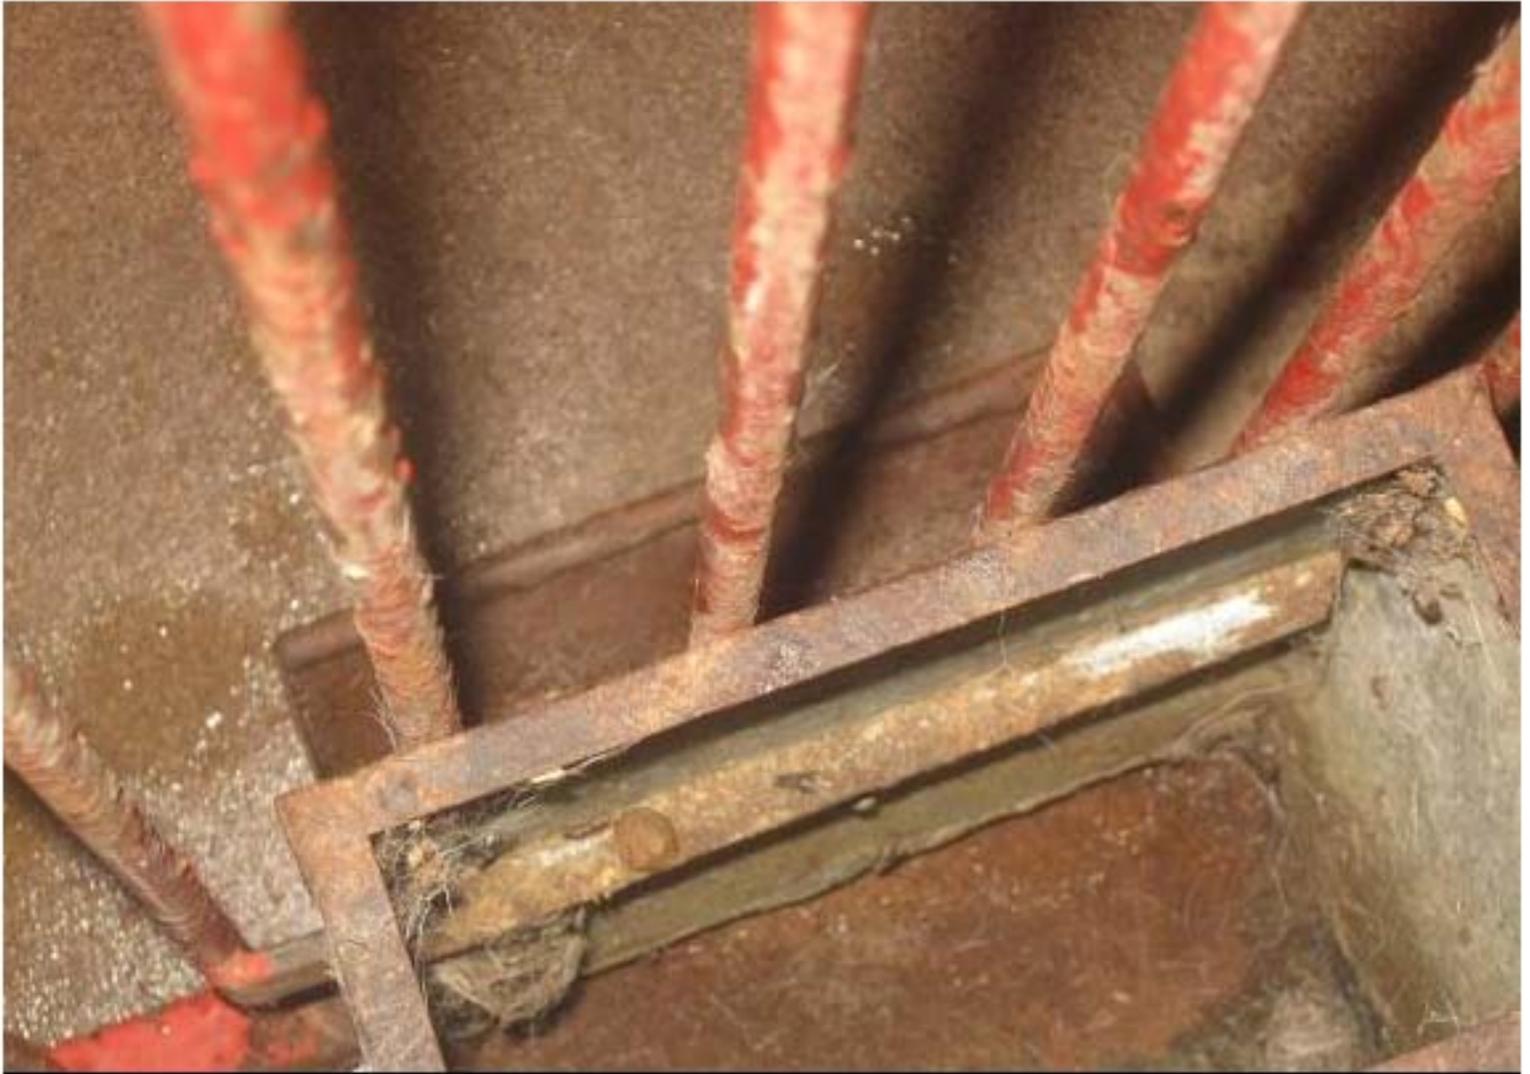
CFR: 3.1 (c) (1) (i)

Photographer:	Randall Wagner (ACI)	Legal Name:	Registration:	42-A-1253
Photo Taken:	Thu, Sep 23, '10	DAVE RUTER		
Inspection:	280100021210681			
Description:	The metal feeder's surface is excessively rusting and flaking.
